Special Feature 1. The Great Kanto Earthquake and Disaster Management in Japan

Chapter 1. Looking back on the 100 years after the Great Kanto Earthquake

Section 1. Aspects of the Damage Caused by the Great Kanto Earthquake

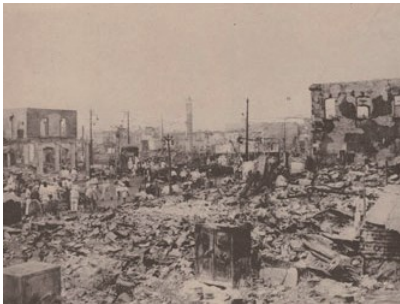
Burnt ruins near the current Ginza 4-chome intersection
Source: Tokyo City "Tokyo Earthquake Records"

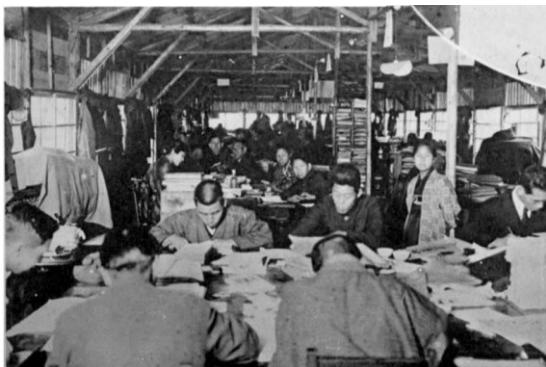
Fig. 1-5 Operation and Organization of the Interim Earthquake Relief Secretariat

The interim earthquake relief secretariat (Figure 1-5) was established in the Home Ministry with the Prime Minister as president and the Home Minister as vice president. The first meeting of the secretariat was reportedly held at around 3:00 p.m. on the afternoon of September 2, approximately 27 hours after the disaster.

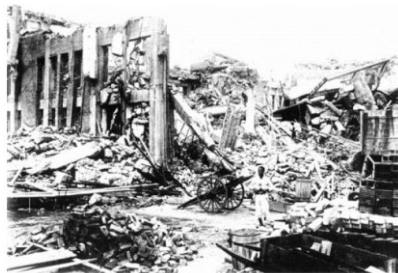
Photo 3. Damage to office buildings in Marunouchi, Tokyo

Naigai Building
(Destroyed during its construction)

Under such circumstances, damage to buildings due to the Great Kanto Earthquake occurred mostly in brick buildings, wooden buildings, and foreign-style buildings without consideration of seismic structures, while Japanese-style earthquake-resistant buildings suffered less damage. For example, the Industrial Bank of Japan in Marunouchi, which was under construction at the time, survived the earthquake almost undamaged. Its structure was designed by Tachu Naito, an architect who studied under Toshikata Sano, famous for his seismic design research. On the other hand, some of buildings built by foreign construction companies collapsed during construction, resulting in the deaths of workers and the need for large-scale renovations.

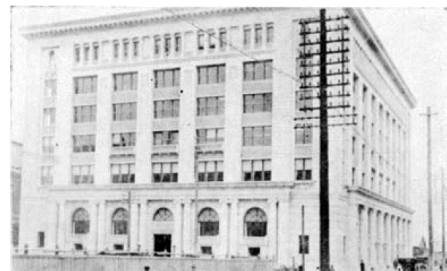
Industrial Bank of Japan (It was completed in 1923 and designed by Tachu Naito, incorporating earthquake-resistant walls.)

As a direct result of the massive damage to buildings caused by the Great Kanto Earthquake, the structural strength requirements of the Urban Building Law Enforcement Regulations (Home Ministry Ordinance No. 37 of 1920) were revised in 1924, the year after the earthquake. This led to the world's first seismic force-related regulations. After the war, the Urban Building Law (Act No. 37 of 1919) was replaced by the Building Standards Act (Act No. 201 of 1950), which covered the whole country. However, the seismic provisions at that time are regarded as equivalent to the current seismic resistance standards even though they have changed in appearance.
