Special Feature

Consecutive Disasters --Toward the Establishment of a Disaster Conscious Society--

Chapter 1 Disasters in 2018

Section 1 Consecutive Disasters

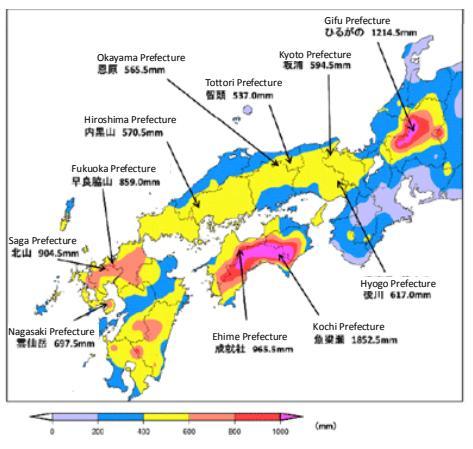
Distribution of the maximum 72-hour precipitation during the event (between 00:00 on June 28 and 24:00 on July 8)

The total precipitation from June 28 to July 8 exceeded 1,800 mm in some areas of the Shikoku region and 1,200 mm in some areas of the Tokai region, recording two to four times the average monthly precipitation in July. In addition, the largest 24-hour, 48-hour, and 72-hour precipitations in recorded history were observed at many observation points in the northern Kyushu, Shikoku, Chugoku, Kinki, Tokai, and Hokkaido regions. The record-breaking heavy rainfalls affected an enormous area of Japan over a long period of time.

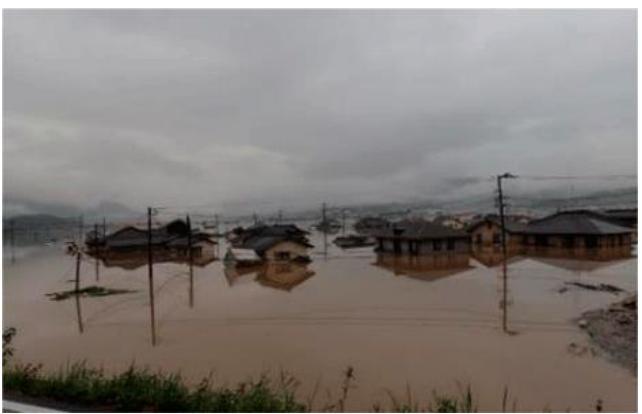
Flood in Mabi Town, Kurashiki City, Okayama Prefecture

In Hiroshima Prefecture, debris flows occurred concurrently in several locations, including Hiroshima City, Kure City, and Saka Town. In Okayama Prefecture, a massive flooding disaster occurred in Mabi Town, Kurashiki City, and other areas due to the breach of levees along the Odagawa River and other rivers. This levee breach was caused by the water level remaining high over a long period of time due to a "backwater phenomenon" (meaning that there was no or little current of water) at the point where the tributary, the Odagawa River, met the main stream, the Takahashigawa River. In Ehime Prefecture, river flooding occurred due to a heavy rainfall exceeding the capacity of river control facilities. Debris flows occurred in Yoshida Town, Uwajima City, which caused a sediment disaster that destroyed a water purification plant.

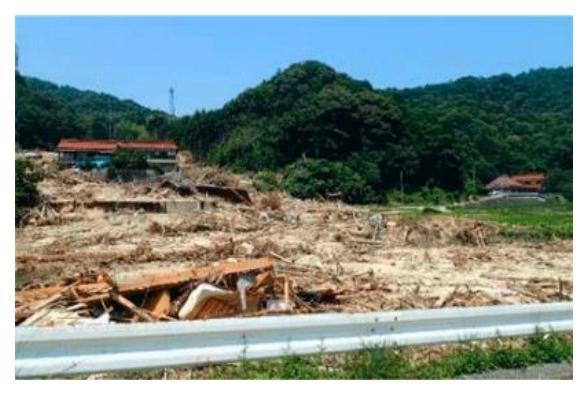
Damage from a sediment disaster in Yasu-ura Town, Kure City, Hiroshima Prefecture

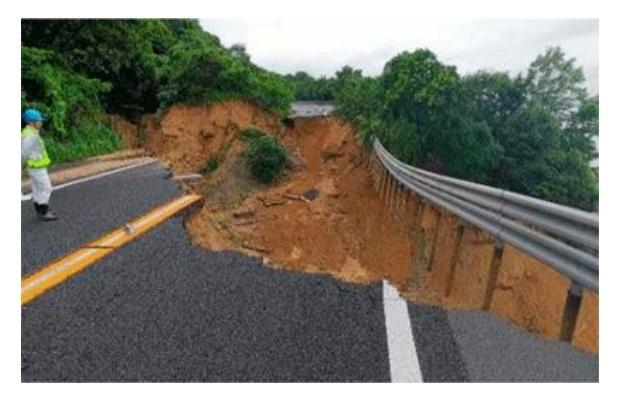
A road cave-in in Mizushiri District, Saka Town, Aki-gun, Hiroshima Prefecture (Hiroshima-Kure Road)

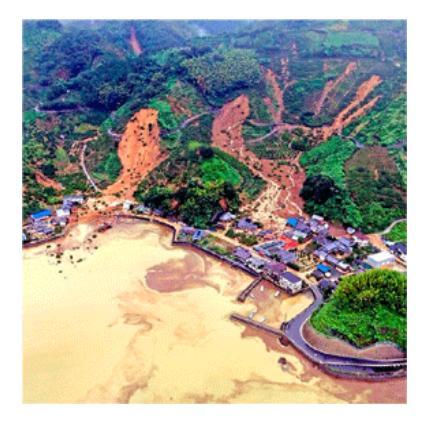
Sediment disaster near Yoshida Town, Uwajima City, Ehime Prefecture

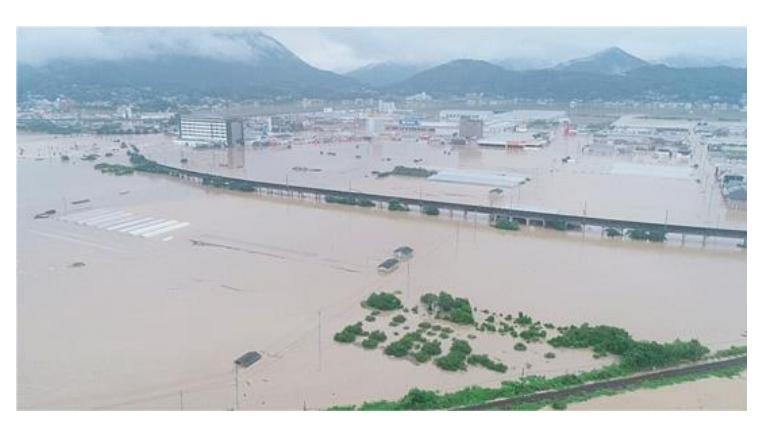
Flood in Higashi-Ozu District, Ozu City, Ehime Prefecture (Photo by courtesy of Ozu City)

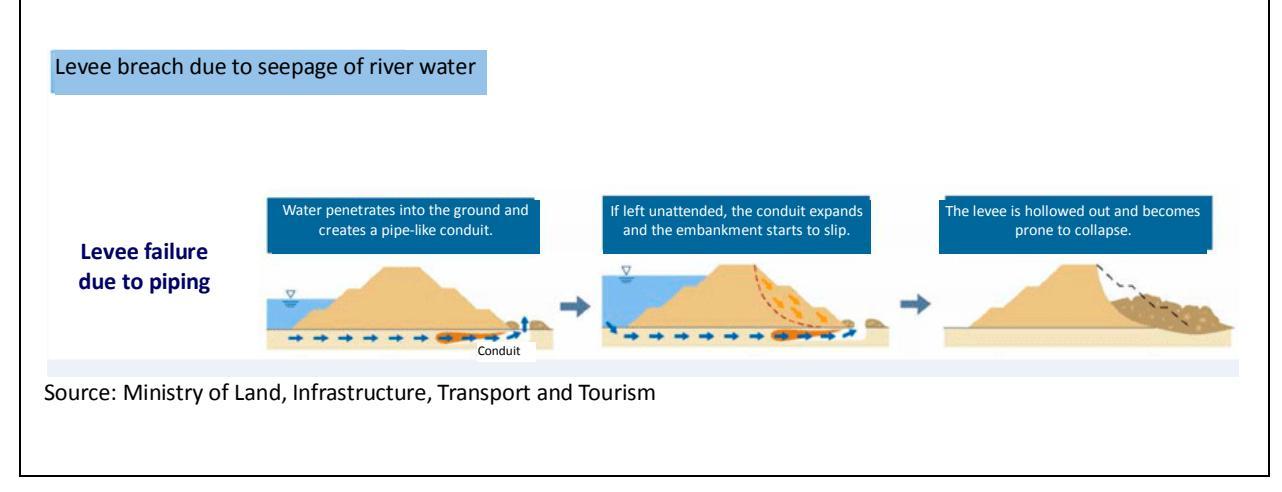
Soil piping is a type of internal erosion phenomenon where a pipe-like structure connecting the inside and outside of a levee is developed. When the river level rises and the pressure of seepage water on the foundation ground increases, soil particles of the ground (solid particles composing the soil) begin to be discharged to the other side of the bank along with the seepage water. This creates and expands a pipe-like hollow structure that eventually becomes a conduit for water to flow. Growing erosion may degrade the security of levees and may eventually cause a levee breach. It has been pointed out that a piping phenomenon can occur in many rivers across Japan. During the Heavy Rain Event of July 2018, piping phenomena were observed at 28 locations in 12 government-administered rivers. In response to this, the government has implemented retrofitting measures as needed, such as installing metal plates (sheet piles) and impervious sheets in the river to reduce water permeation.

There are a few reasons why many rivers are prone to piping phenomena. Firstly, the foundation ground of every river includes some permeable parts (such as the ruins of old rivers) in an intricate manner. The second reason is that the quality of soil and soil compaction methods used are inconsistent for different parts of the same river, because reinforcement works have been conducted on different parts as needed in different times over the long history. Lastly, rising river levels due to heavy rainfalls in recent years and increasing water pressure on levees are also considered to have contributed to piping phenomena.

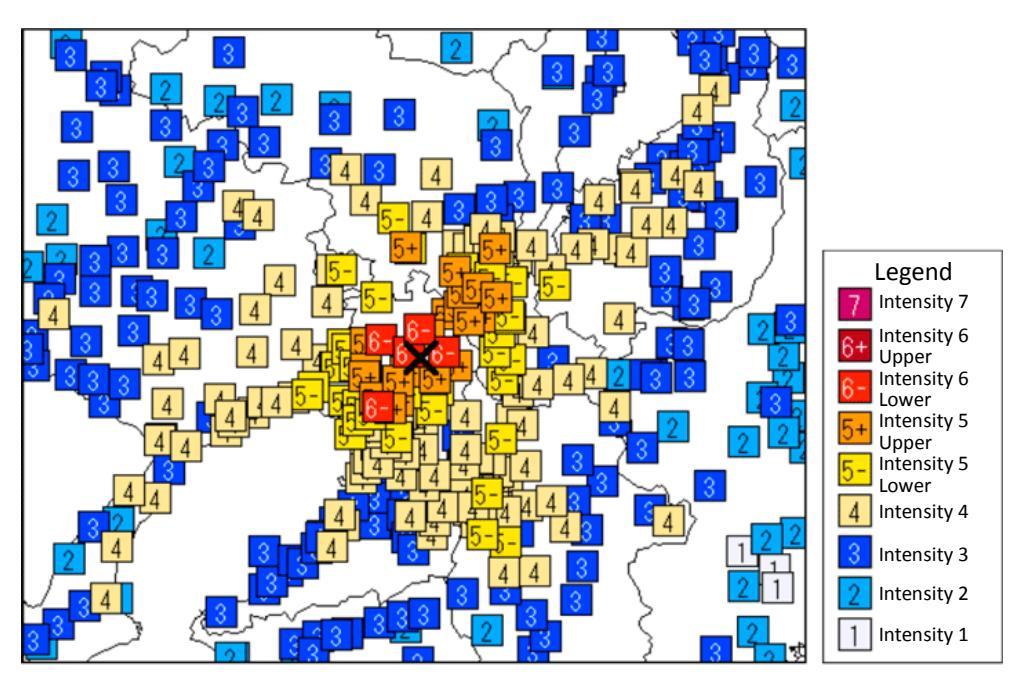
Note) The "x" indicates the epicenter. Source: Press release from the JMA (as of June 18, 2018) (Reference: https://www.jma.go.jp/jma/press/1806/18a/201806181000.html)

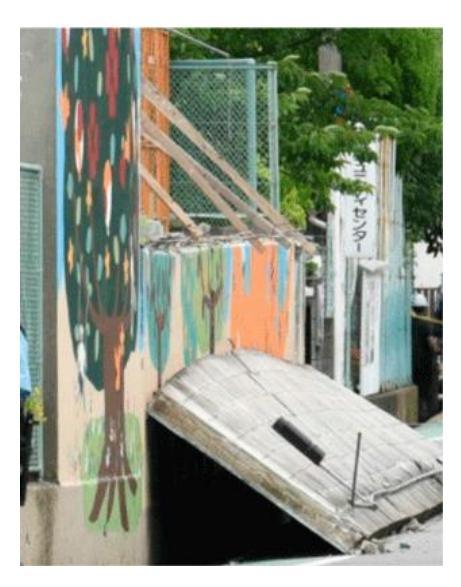
A concrete block wall along a swimming pool, which collapsed during the earthquake (Takatsuki Municipal Juei Elementary School, Osaka Prefecture)

Casualties of this earthquake were 6 deaths, of which two people were killed by collapse of concrete block walls. Damage to houses included 21 completely destroyed, 454 half-destroyed, and approximately 57,000 partially damaged in Osaka Prefecture and other areas. There were three fires in Osaka City and four fires in Amagasaki City, Hyogo Prefecture. They were both extinguished on the same day. No person died from these fires. (Information by the Fire and Disaster Management Agency, as of February 12, 2019. Reference: https://www.fdma.go.jp/disaster/info/2018/)

In response to the incident of a concrete block wall failure, the Ministry of Education, Culture, Sports, Science and Technology (MEXT) instructed Boards of Education in Osaka and other prefectures to strengthen DRR measures to secure students' and facilities' safety. On the following day of the disaster (the 19th), the MEXT issued a notification to all Boards of Education across Japan to urge them to carry out safety inspections of concrete block walls in schools. The MLIT published the Check Points for the Safety Inspection of Concrete Block Walls on June 21 and asked local governments to warn wall users. In addition, the government amended a part of the Order for Enforcement of the Act on Promotion of Seismic Retrofitting of Buildings in order to obligate the implementation of the same seismic tests as buildings for concrete block walls along evacuation routes. The amended Order entered into force in January 2019. In line with this, a budget to aid expenses for the removal of concrete block walls that failed the seismic test and diagnosis was allocated from the second supplementary budget for FY2018.

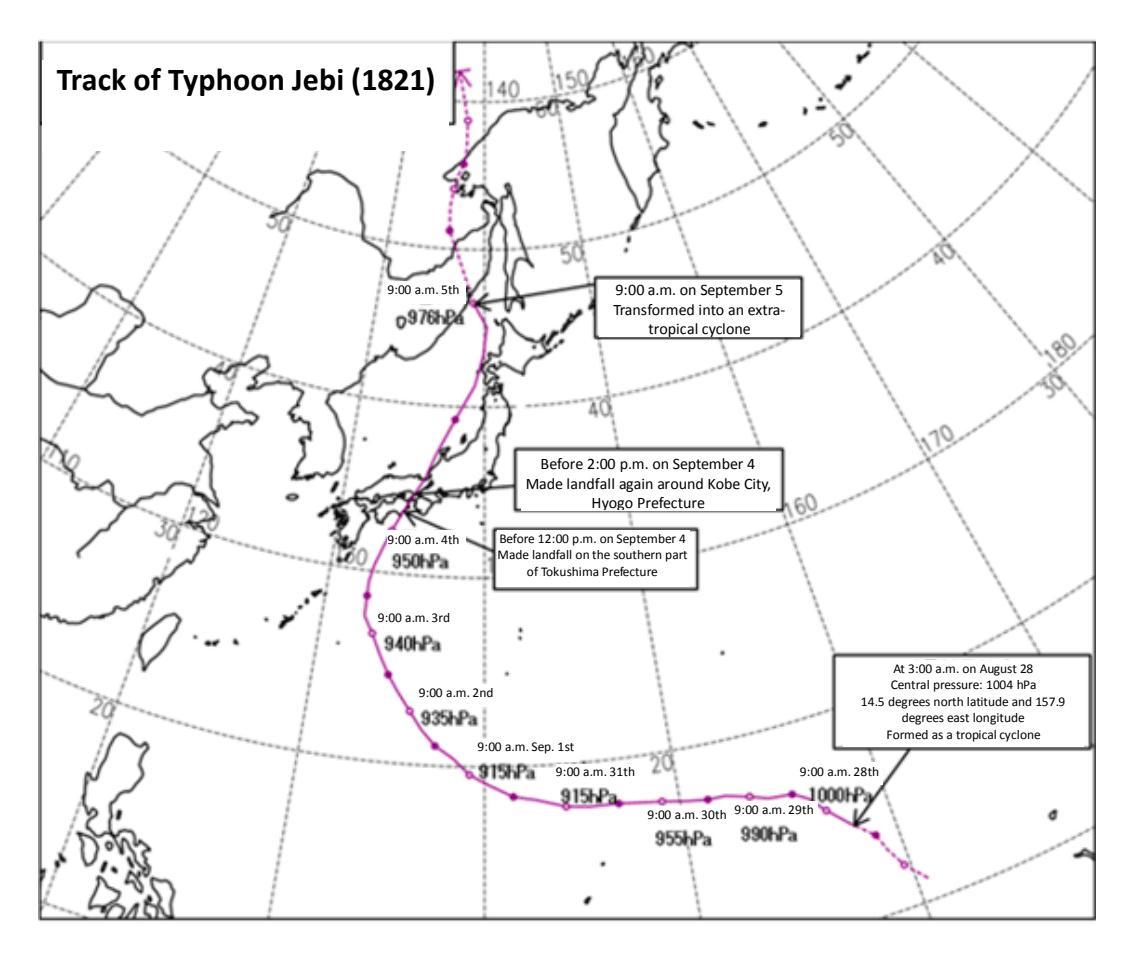
Track of Typhoon Jebi (1821)

Typhoon Jebi (1821) formed as a tropical storm around the Marshall Islands on August 28, 2018 and was upgraded to typhoon intensity around the sea east of the Mariana Islands on August 29. It moved northwestward over the sea south of Japan and made landfall on the southern part of Tokushima Prefecture before noon on September 4. It made landfall with very strong typhoon intensity for the first time in 25 years since 1993 Typhoon Yancy (9313). The typhoon again made landfall around Kobe City, Hyogo Prefecture before 2:00 p.m. on the same day. It crossed the Kinki region while accelerating and then transformed into an extratropical cyclone as it moved northward over the Japan Sea. During the approach and passage of the typhoon, very intense winds and rainfalls hit western to northern Japan. Especially, the areas that were still in recovery from the Northern Osaka Prefecture Earthquake in June suffered further damage and economic losses.

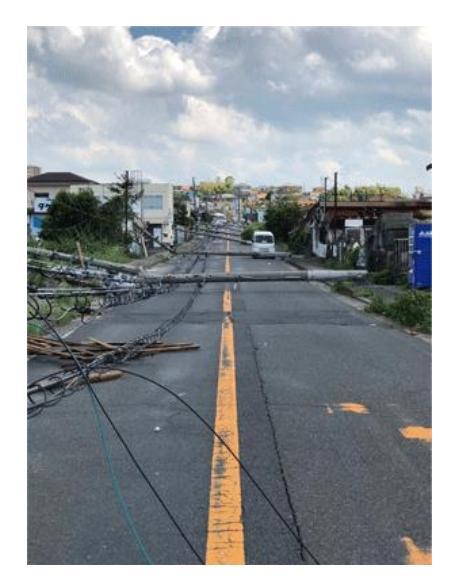
Utility poles overthrown by Typhoon Jebi (1821) (Sennan City, Osaka Prefecture)

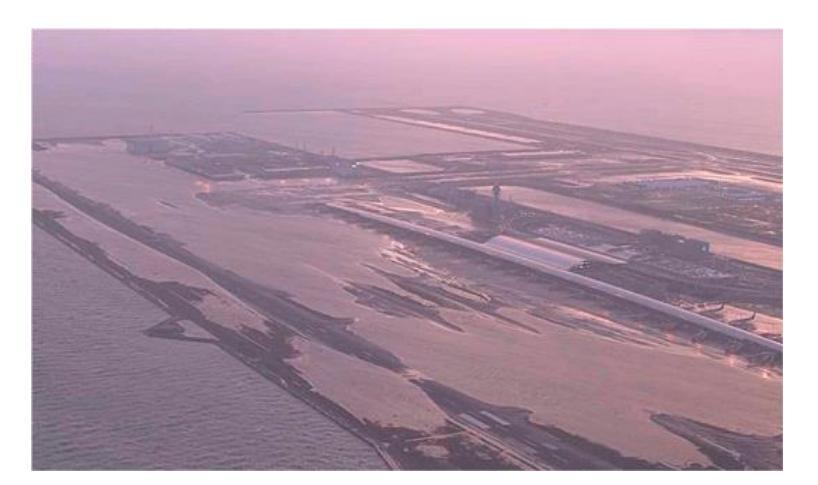
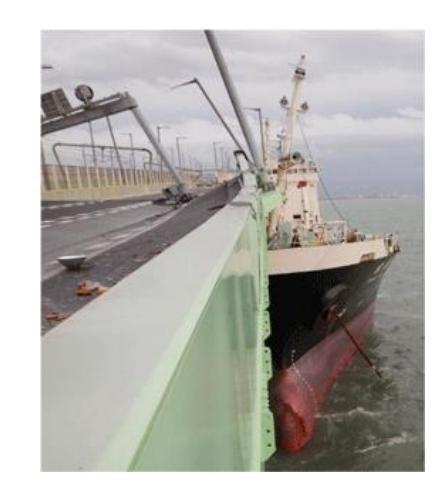
Flood at Kansai International Airport

The Kansai International Airport was flooded from high waves caused by strong winds. There were runway failures and power outages in some parts of the passenger terminal. Moreover, tanker Hounmaru (length: 89 m; weight: 2,591 tons), which was anchored in Osaka Bay, drifted away by the strong winds and eventually collided with the bridge that connected the Airport and the opposite shore. This collision damaged the medium-pressure gas pipeline, resulting in the suspension of gas supply to the airport. With both air transportation and land transportation shut down, passengers were trapped inside the airport.

In response to the damage to the airport due to Typhoon Jebi (1821), the MLIT established the Review Committee on Countermeasures of Large-Scale Natural Disaster for Major Airports in Japan. The Committee determined the direction of preparedness measures and identified urgent issues concerning large-scale natural disasters, in order to secure air transportation networks even in the event of a major disaster. The government intends to promote the updating of airport BCPs and flood countermeasures for the maintenance and restoration of airports as a whole and for securing the stable functioning of major airports in the times of disasters. As for the Kansai International Airport, the government will provide a fiscal loan for the reinforcement of the airport's disaster management capability, taking advantage of the current low interest rate, to the founding company of the airport, which would pay a half of the expenses for short-term and long-term antiflood measures conducted by the airport operator, including the elevation of the bank protection, enhancement of draining capabilities, and anti-flood retrofitting of the power system.

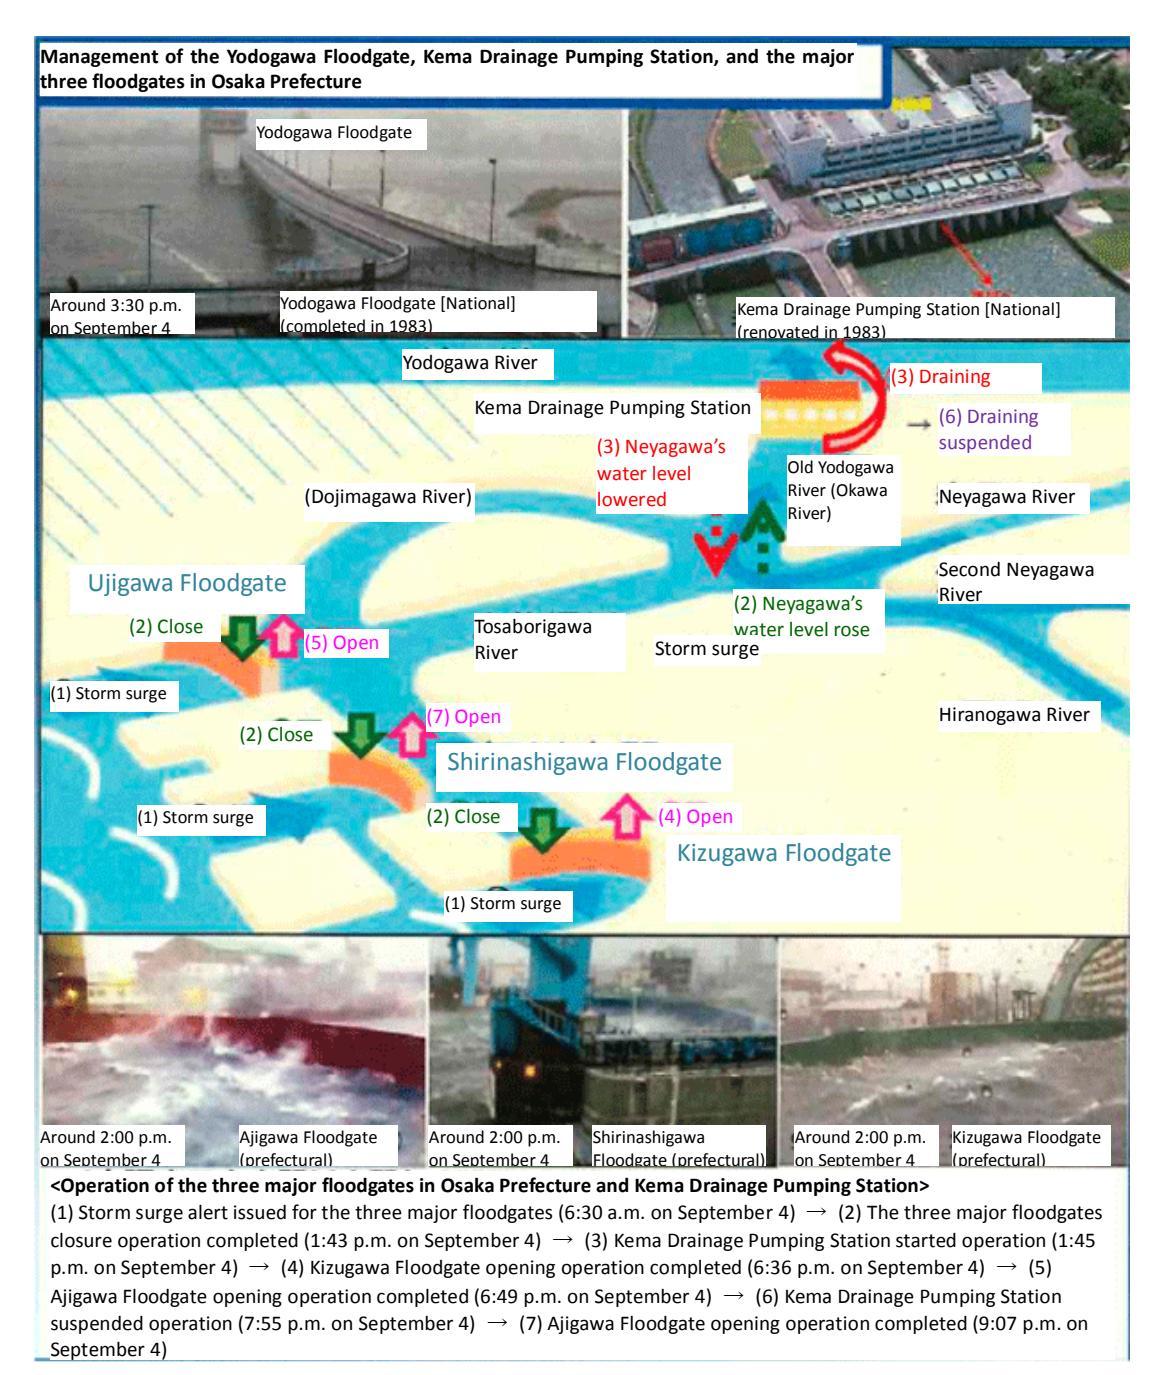
The urban areas of Osaka City managed to avert flooding thanks to the Osaka Bay Storm Surge Countermeasures and the appropriate opening and closure of the Yodogawa Floodwall Gate and the major three floodgates in Osaka Prefecture (Ujigawa-Ajigawa Floodgate, Shirinashigawa Floodgate, and Kizugawa Floodgate).

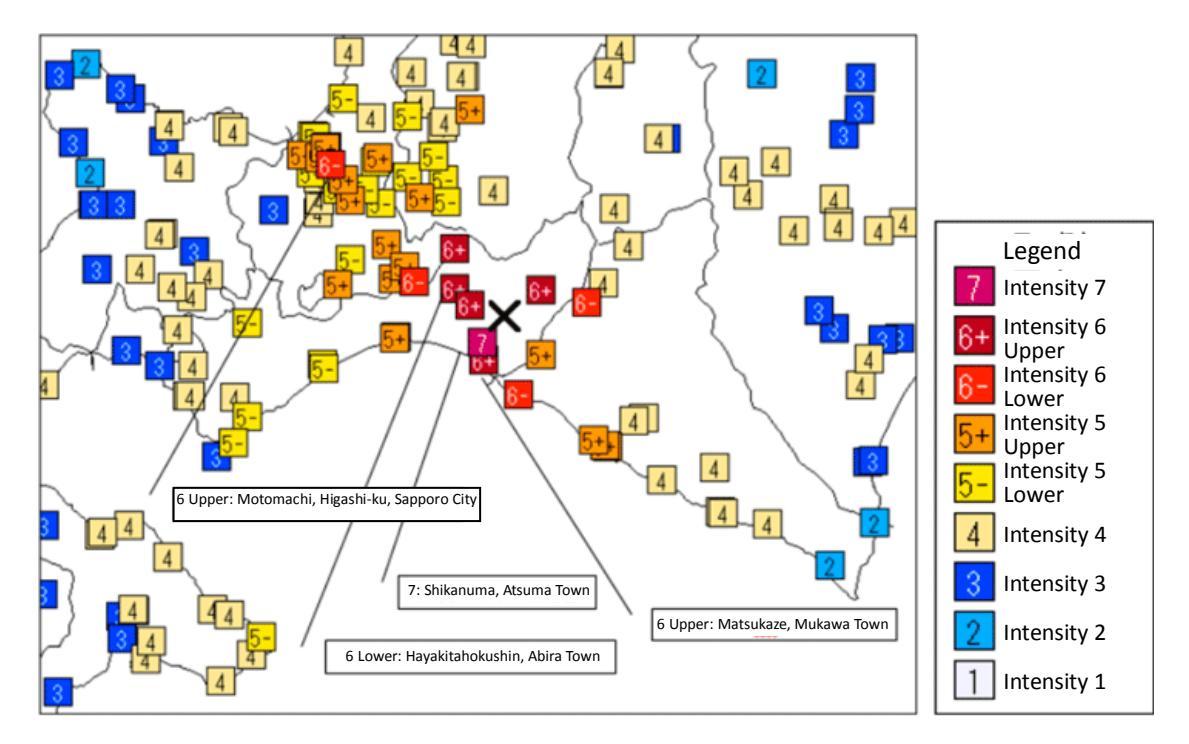
Note) The "×" is the epicenter.

This was the first earthquake with an intensity of 7 observed in Hokkaido Prefecture. It was also the first earthquake with said intensity for Japan since the 2016 Kumamoto Earthquake (6th earthquake with an intensity of 7 in recorded history in Japan). After that, there were 344 earthquakes with an intensity of 1 or higher by the end of March 2019 (1 earthquake with an intensity of 6 Lower, 2 earthquakes with an intensity of 5 Lower, 21 earthquakes with an intensity of 4, 38 earthquakes with an intensity of 3, 89 earthquakes with an intensity of 2, and 193 earthquakes with an intensity of 1).

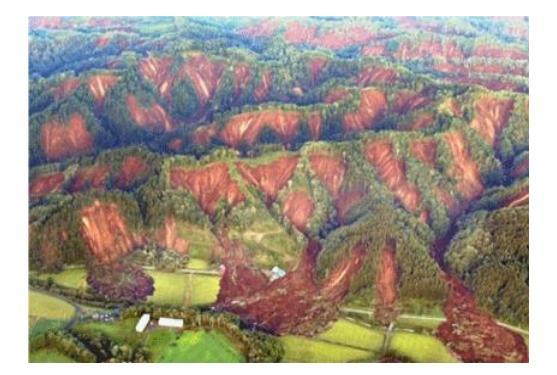
Landslide due to a slip on the fault over approximately 30 km north-south (southern central Hokkaido)

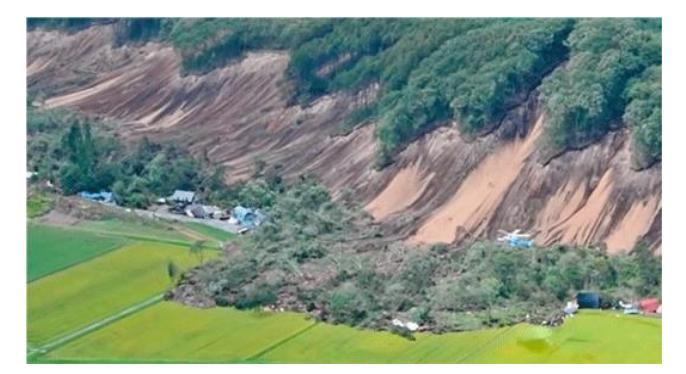
Landslide (Atsuma Town, Hokkaido Prefecture)

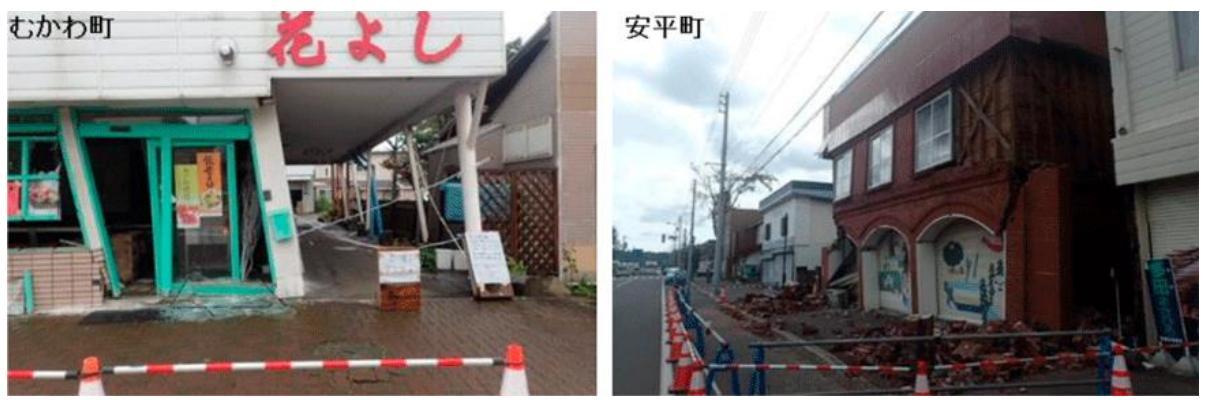
Damage to buildings along shopping streets (Mukawa Town and Abira Town)

Damage to houses included 462 completely destroyed (including 222 in Atsuma Town, 95 in Sapporo City, and 93 in Abira Town), 1,570 half-destroyed (including 684 in Sapporo City, 351 in Abira Town, and 308 in Atsuma Town), and 12,600 partially damaged (including 4,352 in Sapporo City, 3,147 in Mukawa Town, 2,412 in Abira Town, and 1,045 in Atsuma Town).

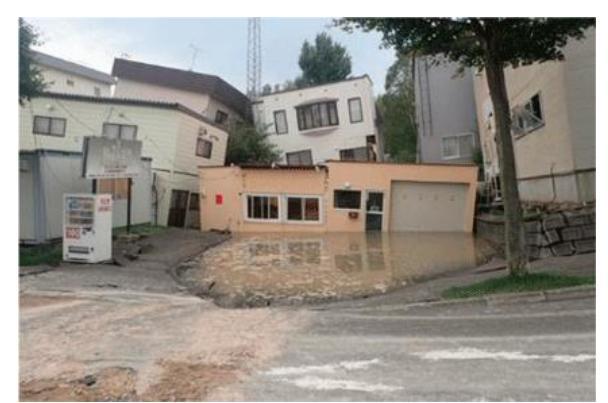
Flood due to a water pipe burst (Kiyota-ku, Sapporo City)

There were many water pipe bursts and ground subsidence due to the earthquake. In particular, dozens of houses were damaged in Kiyota-ku and other residential areas in the hill zone in southeastern Sapporo City. Satozuka District in Kiyota-ku had been reclaimed by filling a valley with volcanic sandy soil. As the groundwater level was high due to Typhoon Jebi (1821), the shocks from the earthquake liquefied the soil deeper than the groundwater level, which was eventually discharged from locations with lower altitudes, causing great damage to houses in the area.

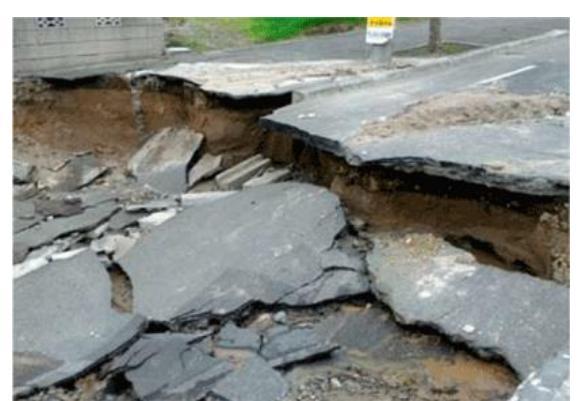
Road failure due to ground subsidence (Hiraoka District, Kiyota-ku)
